WALLINGFORD MARINA

TREE SURVEY REPORT & IMPACT ASSESSMENT

GREENFIELD ASSOCIATES

APRIL 2016

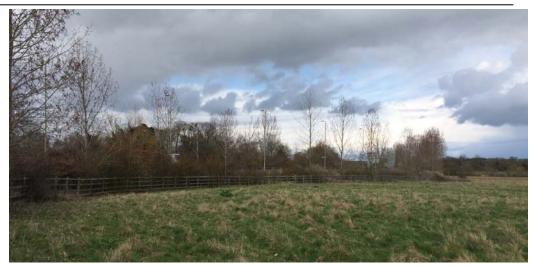
View G19 located just outside the northern site boundary looking west

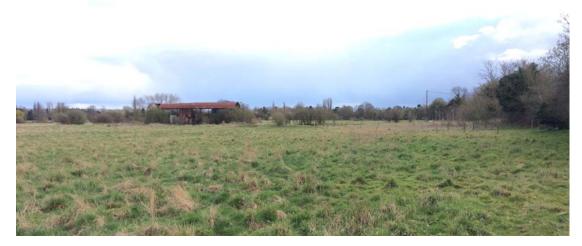
View of G20 & associated trees immediately outside the site boundary looking north
